NUCLEAR WEAPONS EFFECTS TESTS  
OF BLAST TYPE SHELTERS

A Documentary Compendium of Test Reports

# **NUCLEAR WEAPONS EFFECTS TESTS OF BLAST TYPE SHELTERS**

**A Documentary Compendium of Test Reports**

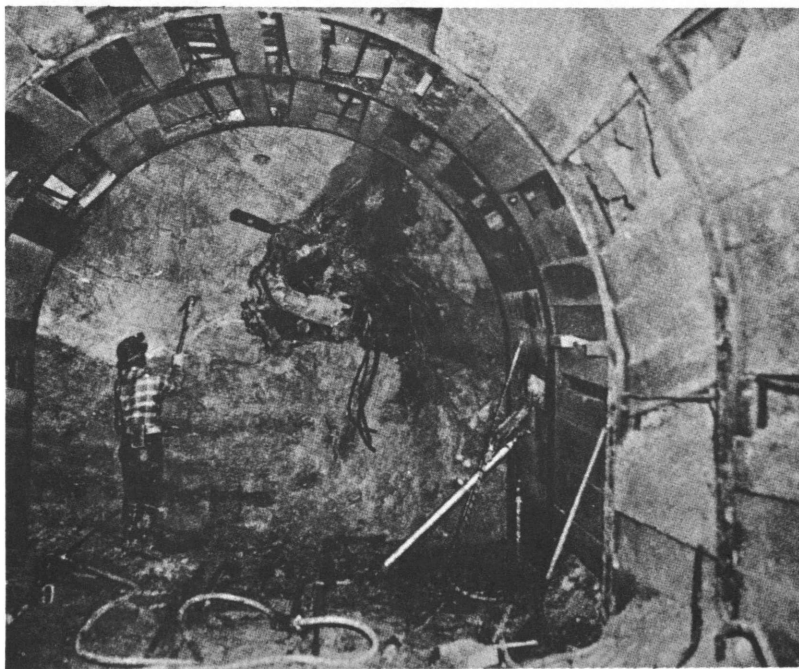
Fig. 10—View at station 19+29, post-Blanca.

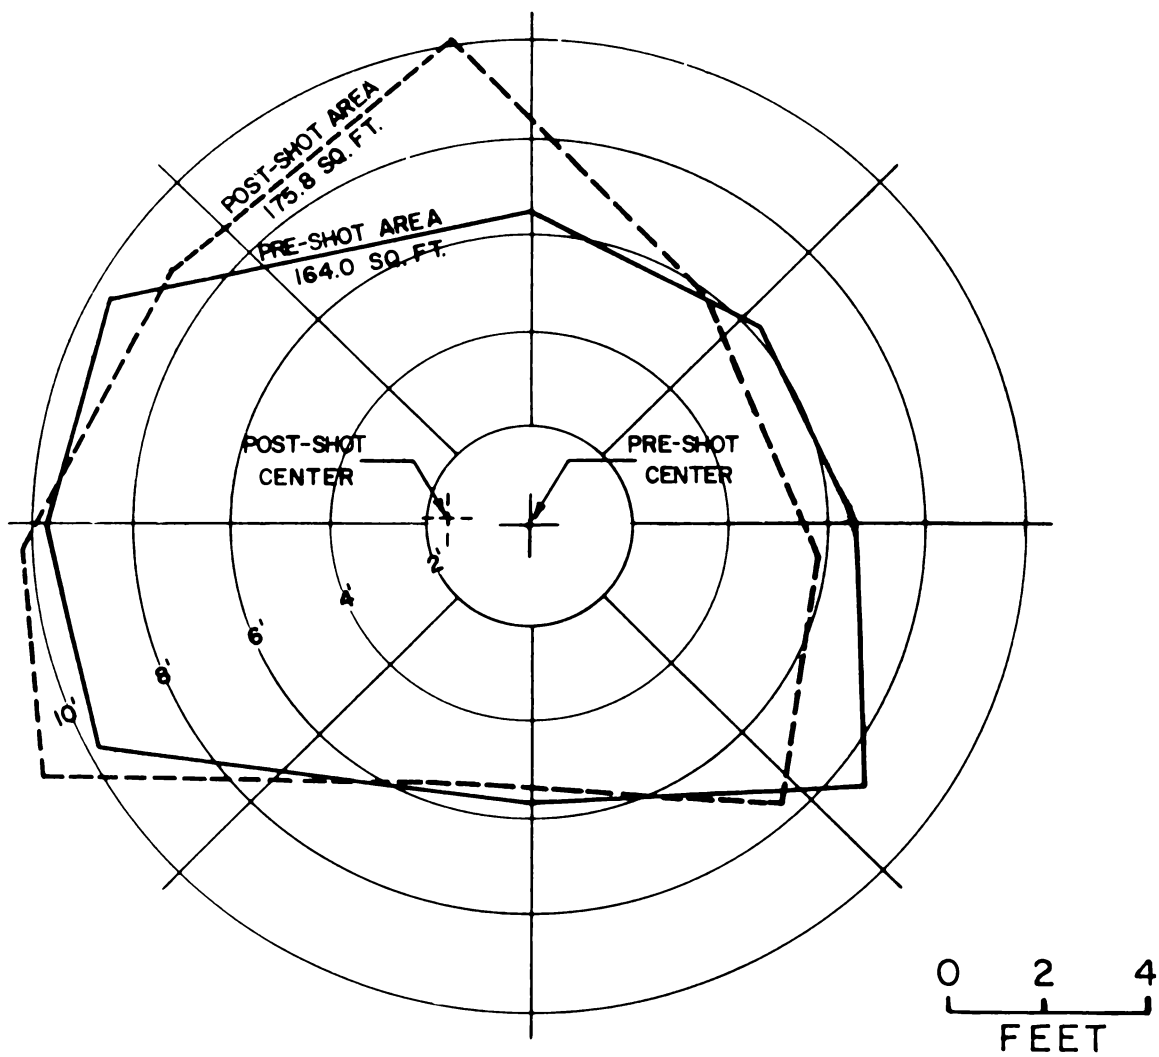
Fig. 11—Preshot and postshot cross sections, drift U12e, station 11+20.
